# Manhole Inspection Summary

Manhole # S1900\_013MH

Insp Date: **7/9/07 8:13 AM**

**Location** Address: **1725 GWYNNS FALL-BRYANT** Cross Street: **REISTERSTOWN RD**

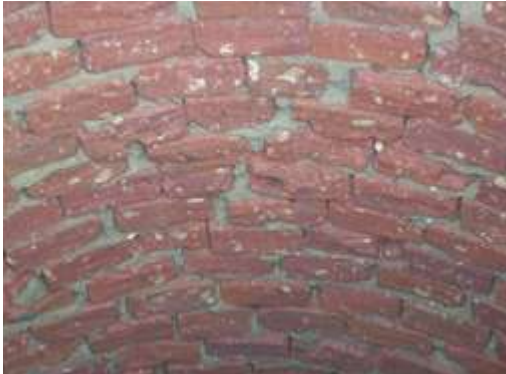
Defect 2

Condition: ☐ Sound ☐ Cracked ☐ Root Intrusion ☐ Loose Brick ☒ **Deteriorated**

Cracked corbel

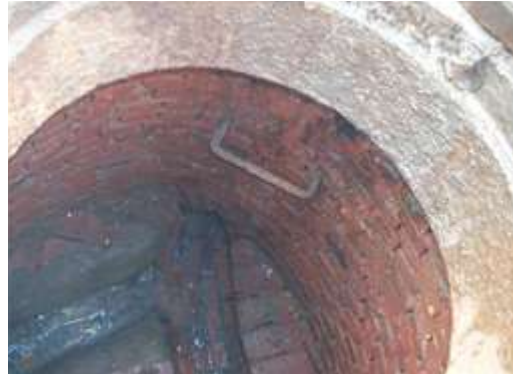
Defect 1

**Steps** Count: **1** Missing: **0** ☒ **Corroded**

CORRODED STEP

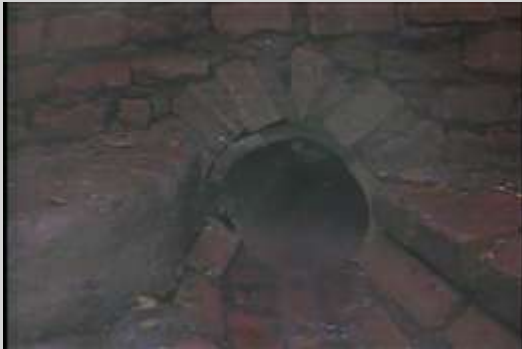
12 O'Clock Outflow

8 in. Circular Gravity Sewer  
Pipe Out @ 12 O'Clock

Pipe Height: **8.4** (in.) Rod and Bar (Angled)  
Pipe Material: **Clay** ☐ Pipe Lined  
Invert Depth: **5.68** (ft.) Flow Characteristics: **Slow**  
Deposits: ☒ None ☐ Mud ☐ Sludge ☐ Debris ☐ Grease  
Silt Depth: (in.) Deposits Extent:  
Infiltration: **None** Pipe Seal Cond: **Broken**

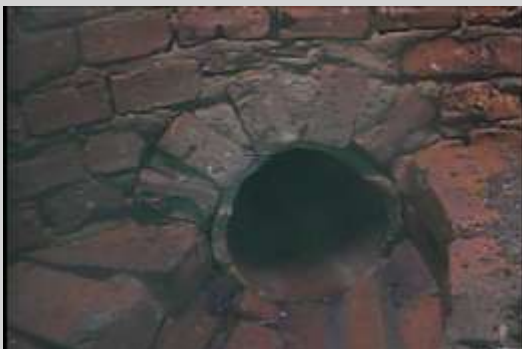
3 O'Clock Inflow

8 in. Circular Gravity Sewer  
Pipe In @ 3 O'Clock

Pipe Height: **8.4** (in.) Rod and Bar (Angled)  
Pipe Material: **Clay** ☐ Pipe Lined  
Invert Depth: **5.35** (ft.) Flow Characteristics: **Slow**  
Deposits: ☒ None ☐ Mud ☐ Sludge ☐ Debris ☐ Grease  
Silt Depth: (in.) Deposits Extent:  
Infiltration: **None** Pipe Seal Cond: **Broken**

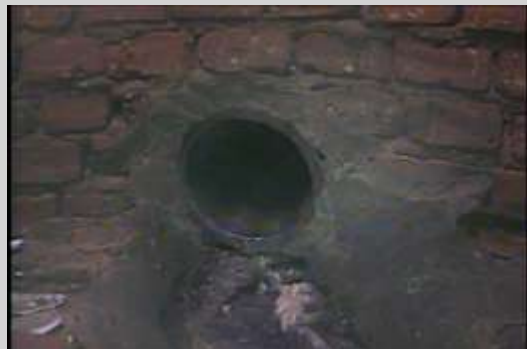
8 O'Clock Inflow

6 in. Circular Gravity Sewer  
Pipe In @ 8 O'Clock

Pipe Seal Cond: **Sound**
